Briefing on Bay Bridge Bolts – June 6, 2013

THE SAN FRANCISCO-OAKLAND
BAY BRIDGE
SEISMIC SAFETY PROJECT

Metallurgical Report on 2008 Bolts, Dated May 7, 2013

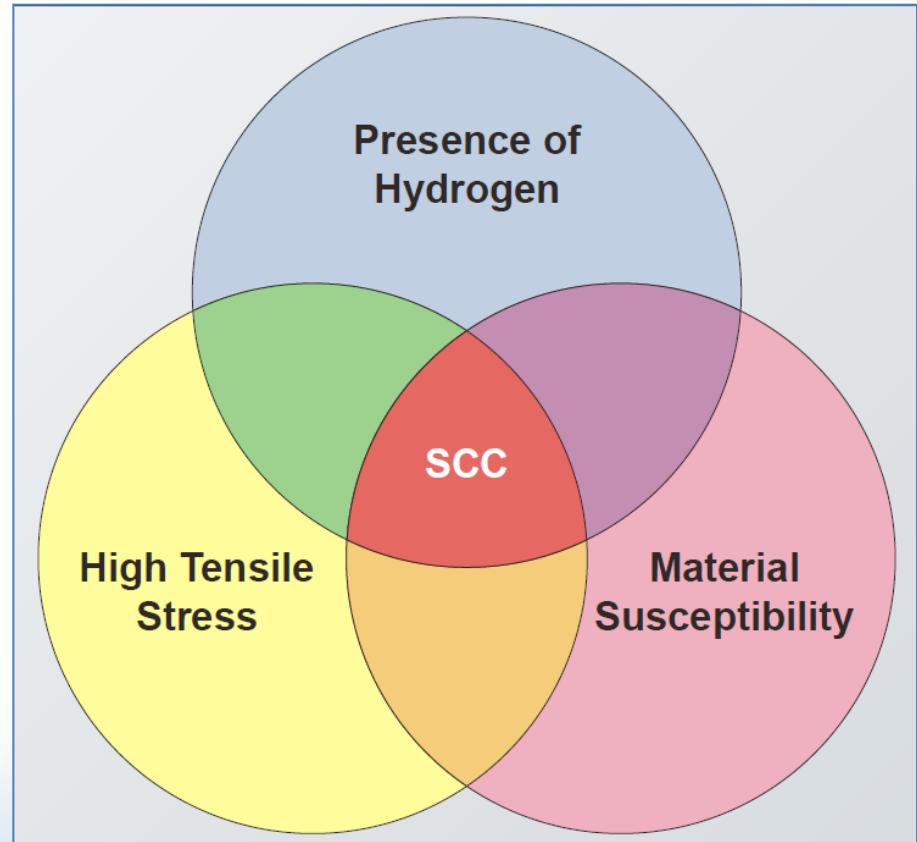
Stress Corrosion

- Based on regular inspection and ongoing testing, remaining bolts continue to perform as designed.
- Longer term concern is whether remaining bolts under high tension might be subject to stress corrosion cracking.
- Long term stress corrosion susceptibility is a function of the size and hardness of material, and level of tensioning.

What to do with other bolts on SAS?

1. Replace before seismic safety opening
2. Replace after seismic safety opening
3. Modify by
 - Dehumidifying
 - Reducing tension
 - Additional Corrosion Protection
4. Acceptance, ongoing monitoring and maintenance

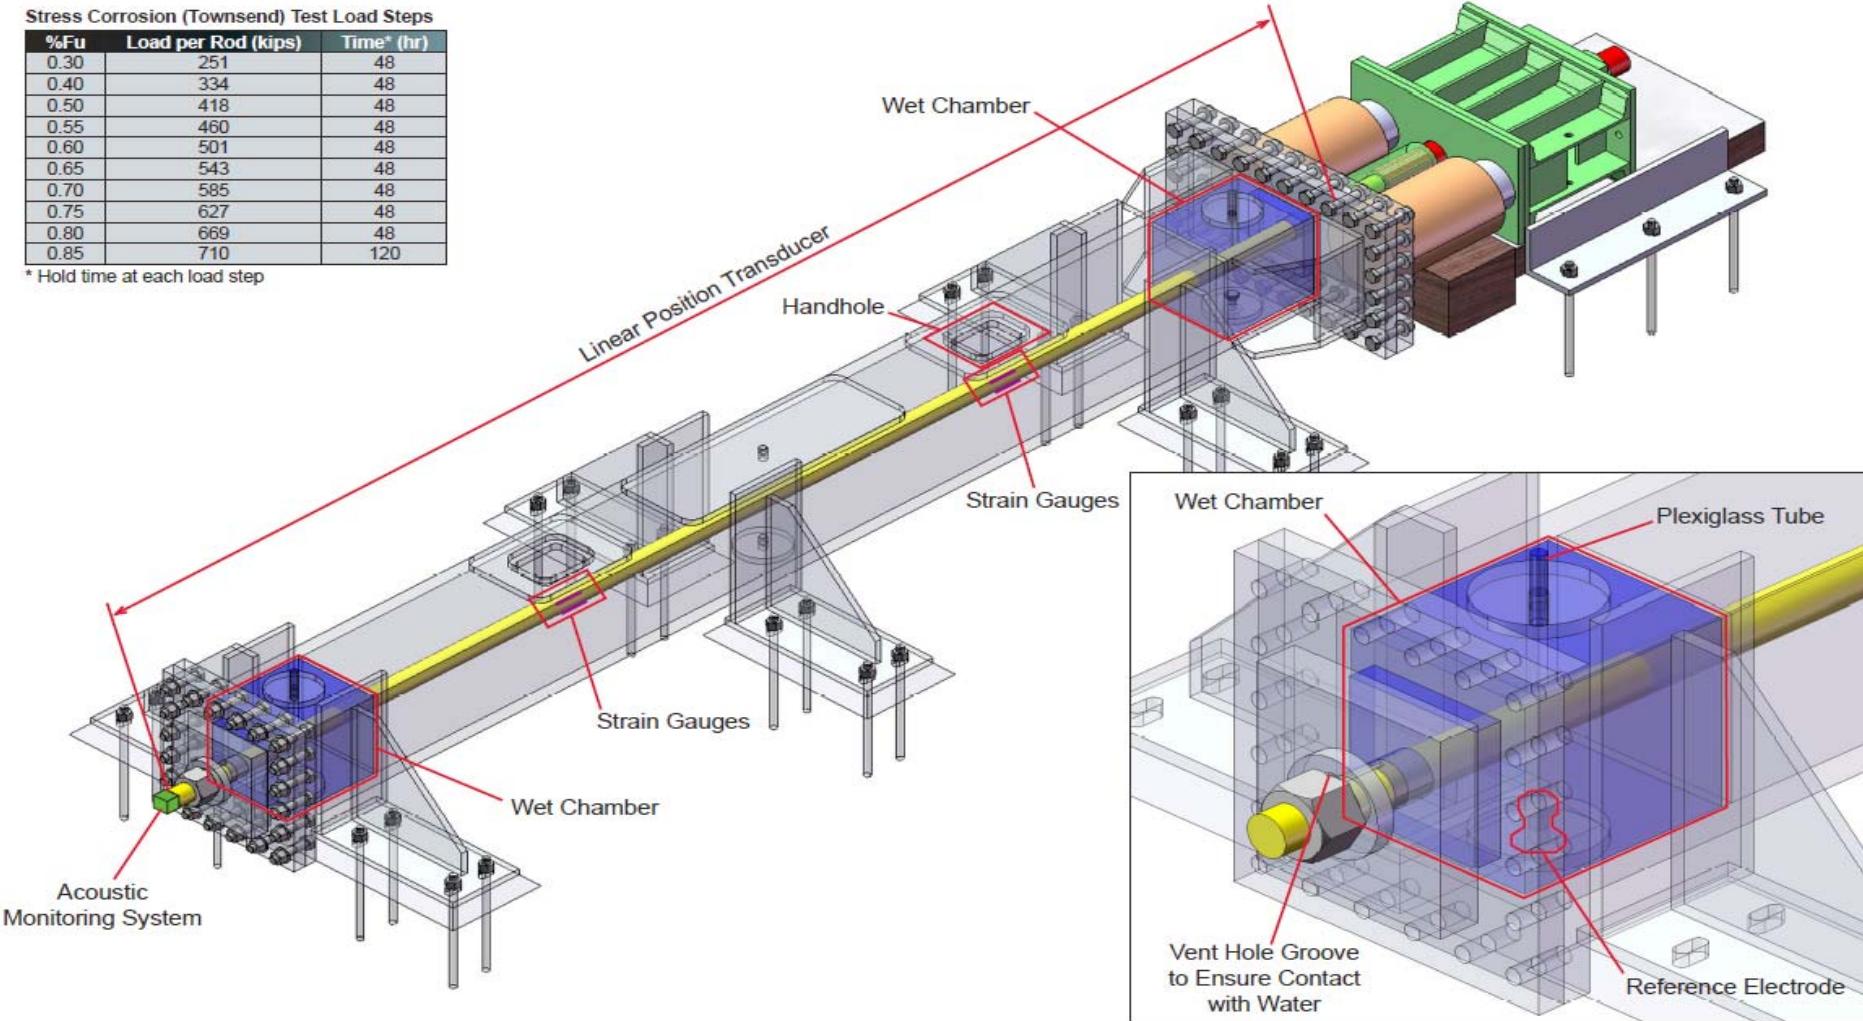
Test Set-up for Stress Corrosion (Townsend) Test

IV. Stress Corrosion (Townsend) Test

- The Townsend test is an accelerated test being prepared to determine the longer term susceptibility of the material to stress corrosion.
- Full sized bolts will be soaked in a controlled concentrated salt solution while tensioned progressively over a number of days until failure.

Stress Corrosion (Townsend) Test Load Steps
